# Manhole Inspection Summary

Manhole # S53GG\_003MH

Insp Date: **6/6/08 9:32 AM**

**Location** Address: **Edison**

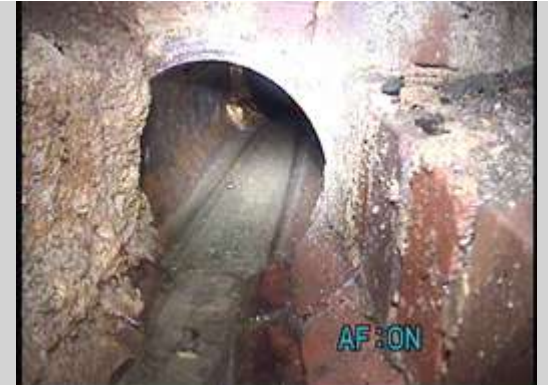
12 O'Clock Outflow

8 in. Circular Gravity Sewer  
Pipe Out @ 12 O'Clock

Pipe Height: **8.4** (in.) Rod and Bar (Angled)  
Pipe Material: **Clay** ☐ Pipe Lined  
Invert Depth: **12.65** (ft.) Flow Characteristics: **Slow**  
Deposits: ☒ None ☐ Mud ☐ Sludge ☐ Debris ☐ Grease  
Silt Depth: (in.) Deposits Extent:  
Infiltration: **None** Pipe Seal Cond: **Sound**

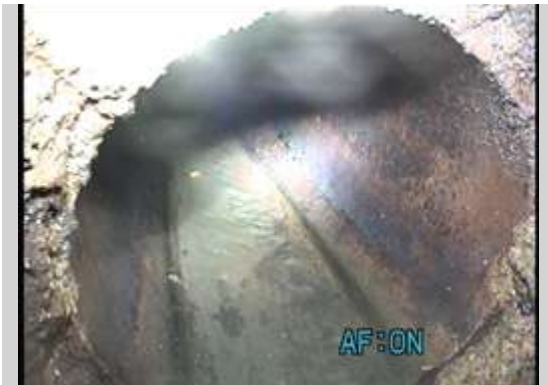
3 O'Clock Inflow

8 in. Circular Gravity Sewer  
Pipe In @ 3 O'Clock

Pipe Height: **8.4** (in.) Rod and Bar (Angled)  
Pipe Material: **Clay** ☐ Pipe Lined  
Invert Depth: **12.55** (ft.) Flow Characteristics: **Slow**  
Deposits: ☒ None ☐ Mud ☐ Sludge ☐ Debris ☐ Grease  
Silt Depth: (in.) Deposits Extent:  
Infiltration: **None** Pipe Seal Cond: **Sound**
